DOWNSTREAM FISH MIGRATION ALONG THE LOW MEUSE RIVER

Installation of a pilot behavioral barrier and downstream fish pass at pilot site 1

Deliverable – On site installation report

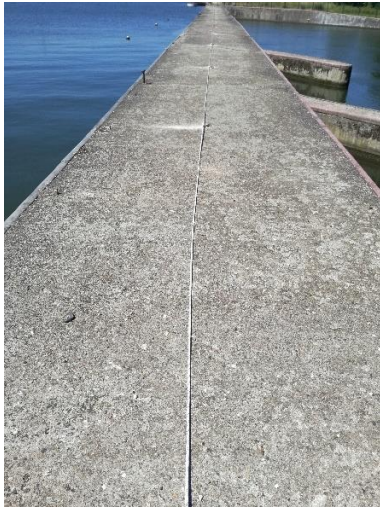
Figure 1 : Lifeline on plunging wall

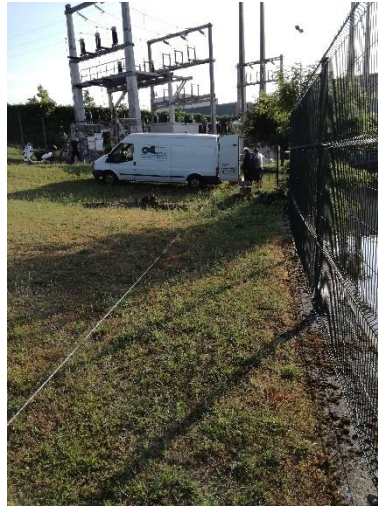
Figure 2 : Lifeline connected to vehicles

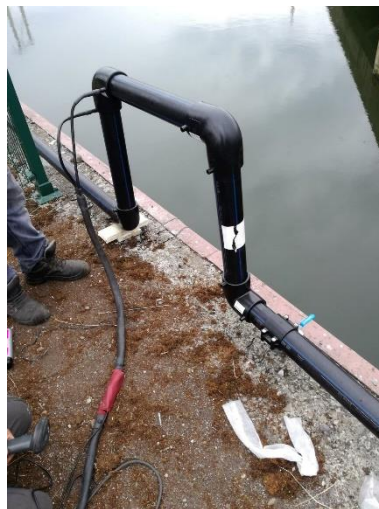
Due to the length of the pipe, we noticed a strong dilation. Expansion loops is recommended to compensate for thermal expansion and contraction. With a length of 160 meters, three expansion loops are used.

Figure 17 : Expansion loop

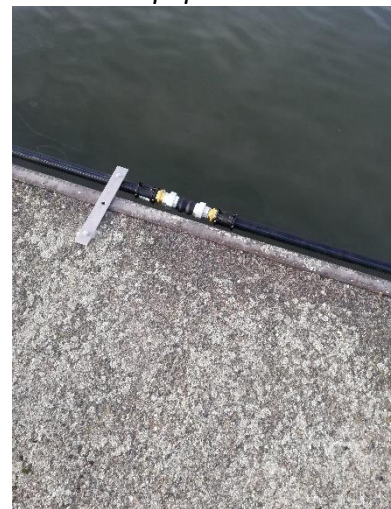
Metal legs have been fixed along the plunging wall to support the pipe feeding the downstream of the bubble curtain. Compensators are installed along the HDPE pipe to limit expansion. Block valves are located at the upstream and the downstream ends of the plunging wall.

Figure 21 : Compensators

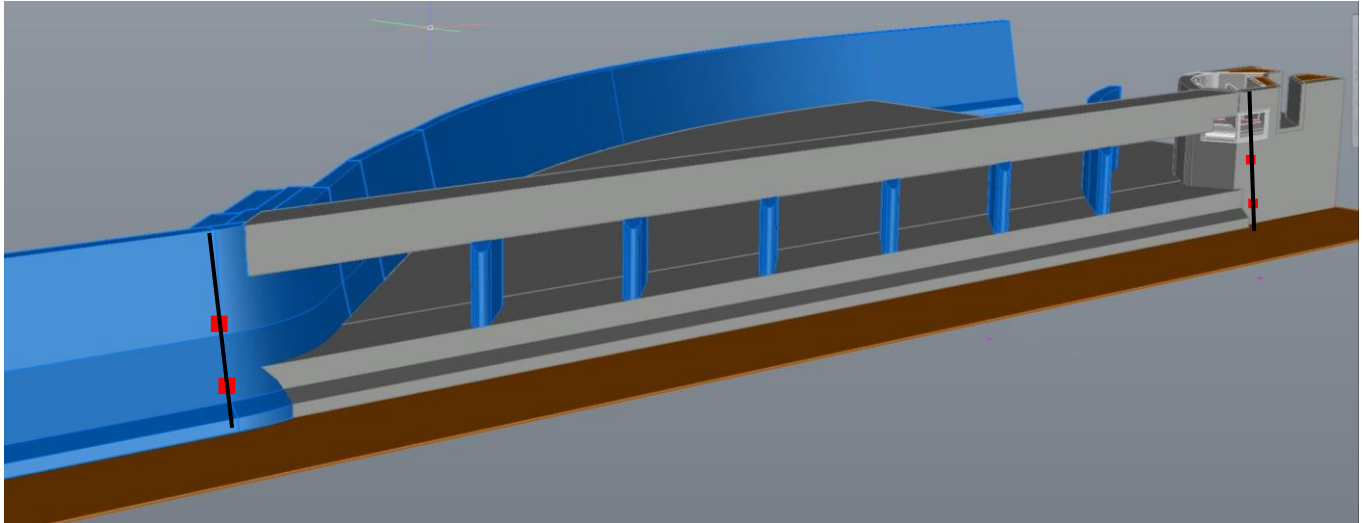
Divers fixed 4 metal parts on the concrete wall. They are used to attach the torpedo hose. The 2 metal parts closest to the bottom are used as anchor points for the bubble barrier. One of the metal parts (downstream) is welded on the sheet piling.

Figure 25: Four metal parts and Torpedo

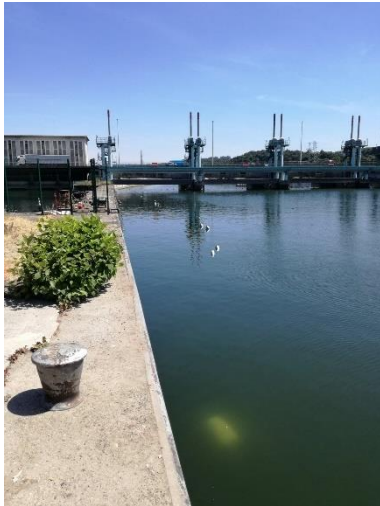
The first job did by the divers was the positioning of the railway sleepers. Based on the layout plan provided by Luminus. To lift and move the concrete blocks into the water, divers use parachute. They use referenced strings for positioning. We decided to set up the bubble pipe at 5 meters from the plunging wall. We thought that at this distance the bubbles would not pass under the wall. We were wrong.

After the first phase of commissioning we noticed that the bubbles rise to the surface near the plunging wall. Only one turbine was operating. We decided to change the positioning of the barrier from 5m to 10m. We ordered an additional distance (30m) of bubble hose from Apumas. After discussion with the divers, the best solution was to place the addition upstream of the barrier. For the connection between the new and the old hose, we used galvanized cylinders and clamps. Moving the barrier in place was difficult for divers (concrete blocks and bubble barrier). The downstream part of the barrier is the most prone to fouling. We believe that over time this part will be the most difficult to release from waste. Divers noticed leaks at the fittings. They have been changed or tightened.

Figure 26 : Concrete block positioning

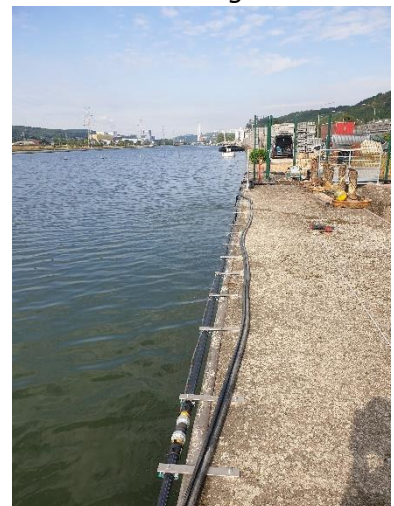
We uncoiled the bubble pipe on the quay. We extracted the steel cable at the landmarks' cord used by the divers before. To prevent slipping of the steel cable into the rubber, we made a loop with the steel cable and a cable clamp. Then the bubble barrier is carefully and slowly lowered into the water to avoid a tear. All connections are made under water by the divers. During the test pressure, we have detected a leak on the bubble curtain, divers plugged it with a steel pipe.

Figure 34 : Bubble barrier ready to go down
