Project: Life4Fish project	EDF Luminus	
Version: V0	Rue du Pont du Val, 1 4100 Seraing ☎ + 32 (4) 330 47 80 - 📠 + 32 (4) 338 24 03 pierre.theunissen@edfluminus.be	Contact name: Pierre Theunissen

DOWNSTREAM FISH MIGRATION ALONG THE LOW MEUSE RIVER

Installation of a pilot behavioural barrier and downstream fish pass at pilot site 1

Deliverable – On site installation report (electrical barrier HPP Grands Malades)

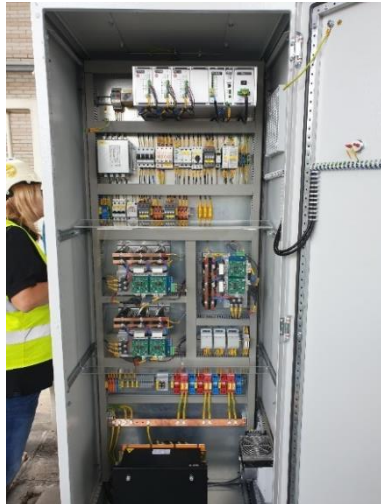
Figure 2 : The electrical cabinet

Electrodes are powered by an electrical cabinet installed by Procom system next to the concrete pills of the bridge. The power cable comes from the power plant and Procom wanted to add a ground cable of 35 mm², but after measurement of the powerplant ground, the initial ground of the power cable appeared to be enough and no additional ground cable was required.

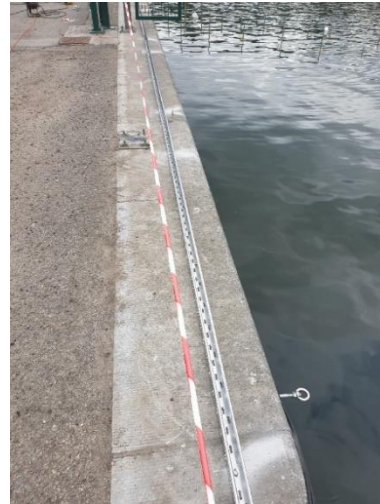
Figure 3 : The Railway cable

Between the barrier and the electrical cabinet, Procom installed a railway for the cables. The railway is in stainless steel because it is outside and near from the water.

The railway cable was installed on the wall for the eel barrier and the salmon barrier by the divers, but the cables of the salmon barrier are not inside yet. Installation of the salmon barrier is foreseen later (end of 2020, beginning of 2021).

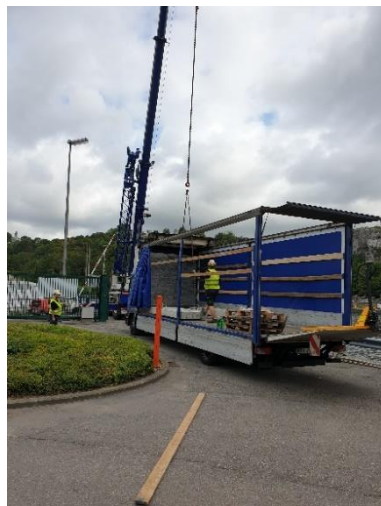
Figure 4 : The delivery truck with the concrete blocks

When the concrete is not covered by sediments, anchors are fixed with mechanical fixation, 2 on horizontal fixations and 4 when the anchor is vertically on the wall. But when the concrete is covered, the system is belayed by railway sleepers. Railway sleepers were ordered by Procom in Poland and came with the transporter. Thanks to a crane, divers put the concrete block in place under water

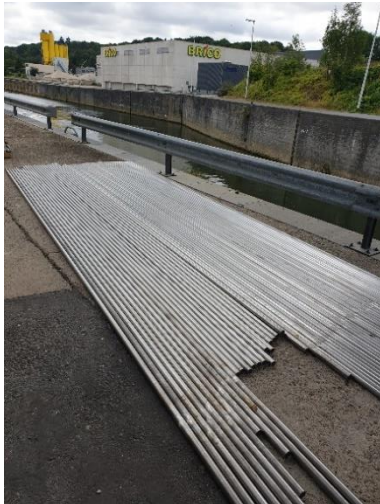
Figure 6 : The stainless steel pipes of the electrodes

The electrodes are made in stainless steel pipe (Figure 5), there are two diameters. The shackles are fixed to the electrodes via a plastic part made for the isolation. The standard length of pipe was 6 meters so where the electrodes needed to be longer, they were extended with a welding, and if needed they were cut. To protect the welding a thermoplastic is put on the welding location.

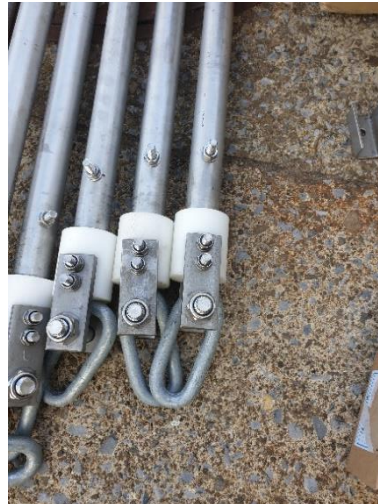
Figure 7 : Electrode fixation and isolation

Procom drilled the lower extremity of each electrode to put the plastic part that isolate and fix the electrode on the chain (Figure 6). Then for the floatability, some buoys are fixed to the electrodes. Two buoys for the larger electrodes, one and a half for the other ones. After a call of their designer, Procom System moved the position of the buoys because it appeared to high.

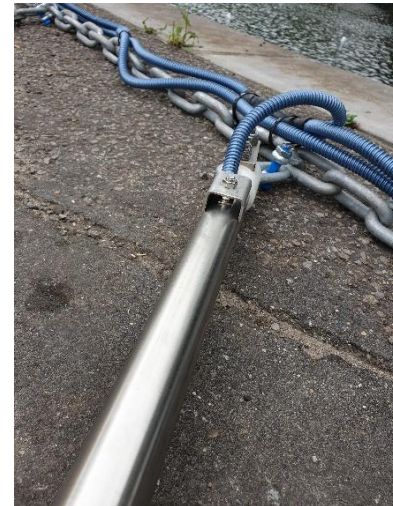
Figure 11 : Electrical connection between the cable and the electrode

Thanks to a galvanized shackle electrodes are fixed to the chain. The electrical connection between the cable is a physical connection, the extremity is locked on a threaded shaft with a screw. A metal cover is ad on the connection to protect the system and in addition to the physical protection, the PUH-255 (sealant) is put inside the metal cover.

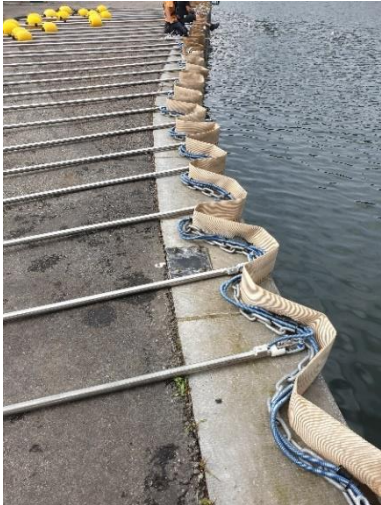
Figure 16 : The water hose before fixed on the chain

Thanks to a water hose fixed in a lot of point on the chain, the whole system was able to float. The water hose is inflated by a small compressor. It make the system easier to move and put in the right position. One extremity was hold with a rope from the otherside of the water. Then electrode after electrode we put the system into the water, paying attention that no one is between electrodes in case of a fall in the water of the whole chain carried away by its weight. Once the barrier is on position, divers cut the rope to make the system down.

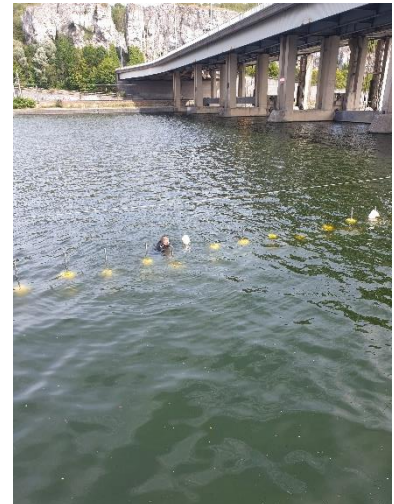
Figure 21 : Divers moving the buoys

The first barrier, the one with the cathodes was set up without any delay. Divers put shackles to fix the chain to the concrete blocks and the anchors. But then Procom asked to the divers to move the buoys because they were too high. Divers proceeded by two, one maintained the position of the buoys while the second fixed it. This delay represented about half a day.

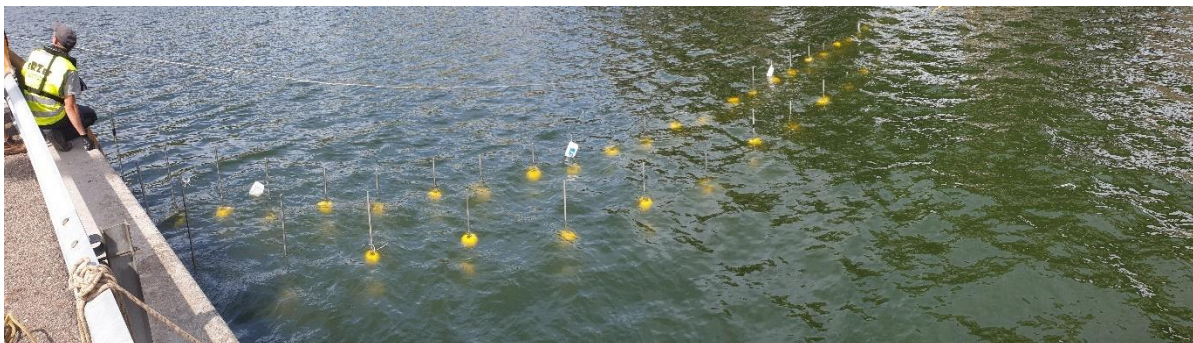
Figure 22 : The barrier after the first installation

For the second one there were more problems, at first, the barrier was too long. Two electrodes was against the wall. So the extremity of the barrier had to be put out of the water to cut the electrodes and let the surplus of chain in the water. Some workers hold the chains and electrodes while another one take down the shackles. Then divers fix the chain in the depth. This operation did not take a long time but was a delay. The two barrier were in the water.

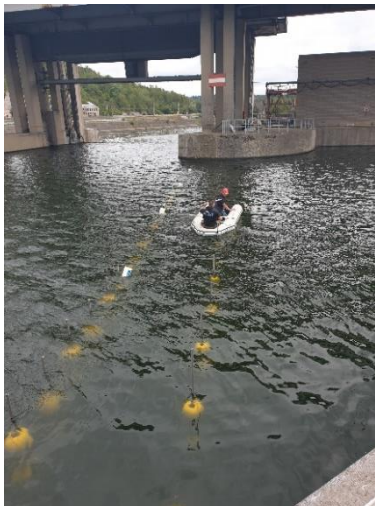
Figure 23 : Divers cutting electrode from the boat

Once the barrier was installed, the electrode length above the water was very important. Procom asked to the divers to cut the part of the electrode which was not in the water. It was not in the scope of the divers but a polish worker did not want to go on the boat and use the grinder to cut, divers did it. They cut several electrodes some parts was more than one meter and the longest has a length of 1,55 m.

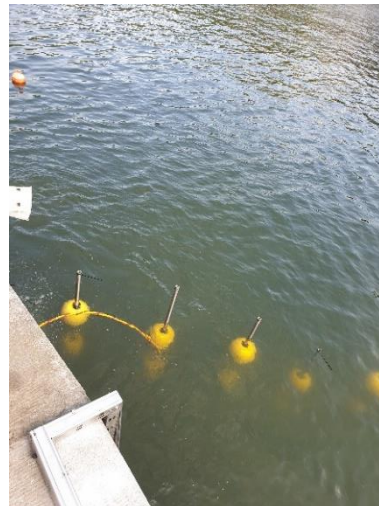
Figure 24 : Electrodes after cut with the marking of the water level before cut (colson)

But with the loss of weight due to the electrode part removal, the whole system rose to the surface. The distance between the chain and the bottom varied but the biggest distance was about 85 centimeters. Some ways to

make the system to be heavier had to be found. We used some chain residues and fixed it on the chain with shackles and threaded shaft. The barrier was less high but it was another delay on the project.

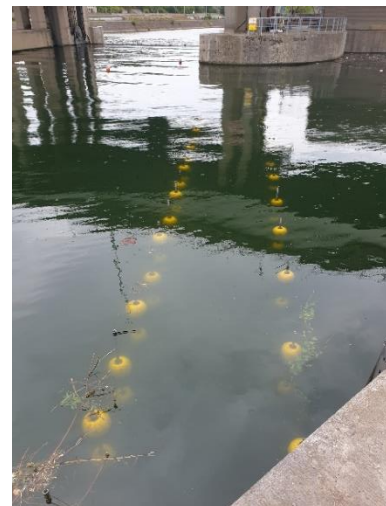
Figure 29 : The barrier before Procom came back to add some part to the shortest electrodes

On the side of the powerplant, the distance between the top of electrodes is too important, up to 1,20 m. So Procom came with some stainless steel pipes and sleeves that the divers fixed to the electrodes to decrease this distance.

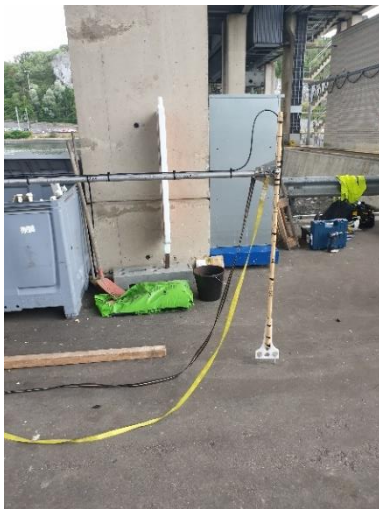
Figure 33 : The tinkered perch for the oscilloscope

Procom did not want to work on the inflate boat lend by Profish so they used another boat from Profish, an aluminum boat. So they tinkered a perch to put the oscilloscope without be in contact with the electricity.

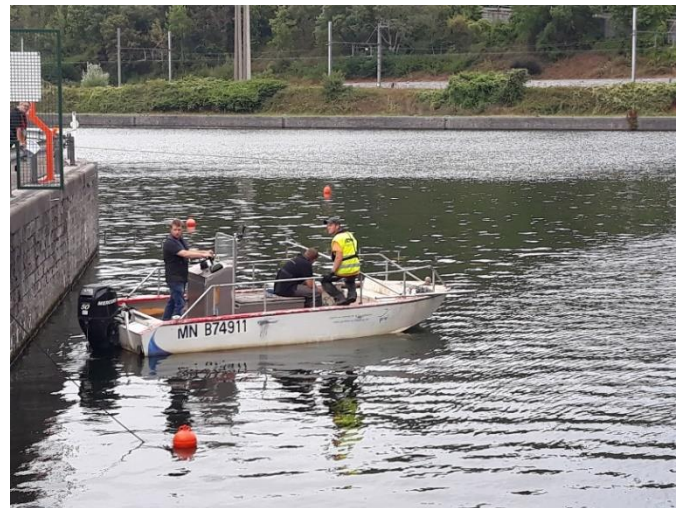
Figure 36 : Measurement from the aluminum boat

After the second measurement phase, the electric field was weaker downstream than upstream of the barrier.

The Polish company has therefore decided to carry out new tests with this time an additional power supply.

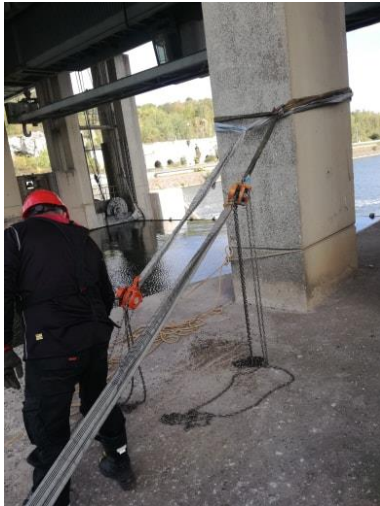
Figure 37 : Take the chain out of the water with a hoist

block chain, they attached a sing to the bridge pier and with a hoist attached to the chain, they pulled out the electrodes. Once electrodes out of the water, Procom has fixed the new electrical cables. Wearing a mask and coveralls was mandatory when using the product to seal the connection.

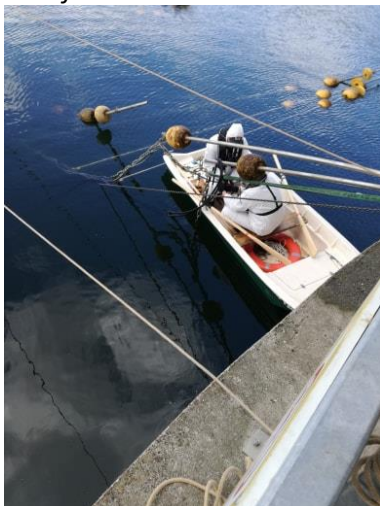
Figure 39 : Electrical connection

The transformer in the electrical cabinet was changed because the power supply was stronger. After the electrical connection, Procom made new measurements to check the electric field. Everything is detailed in Procom's report on the commissioning of the barrier.
