# DOWNSTREAM FISH MIGRATION ALONG THE LOW MEUSE RIVER

LIFE16 NAT/BE/000807

Monitoring of the effectiveness of the pilot solutions

Part II : salmon smolts

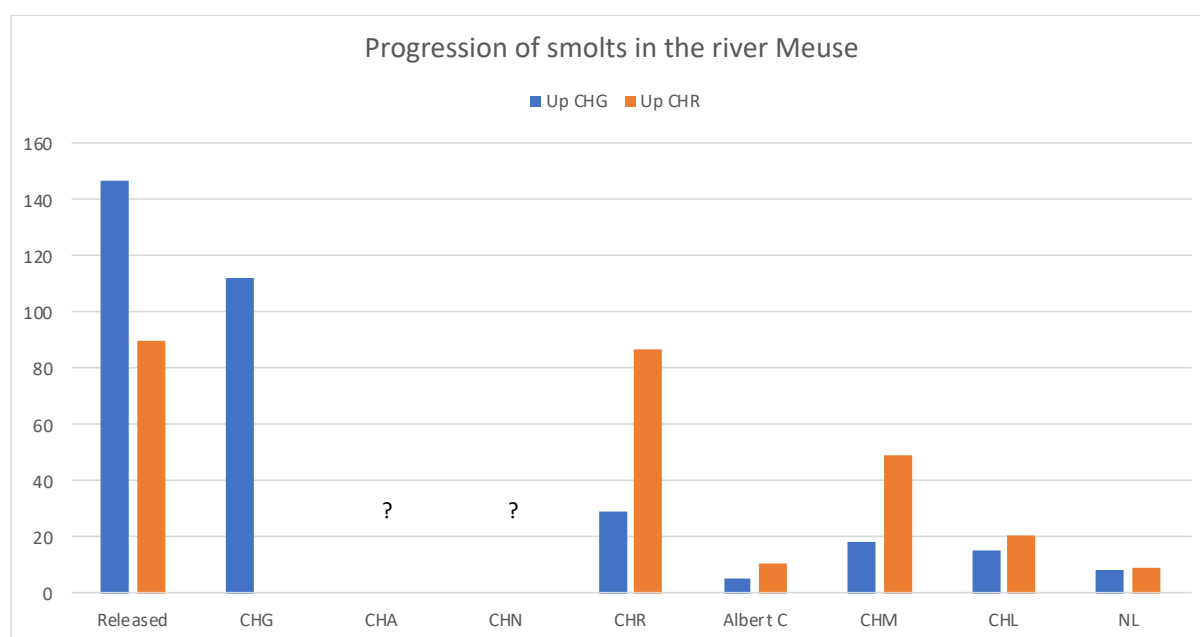
Figure 4 : Number of salmon smolts detected at each site equipped with a telemetry network during the 2021 survey. The smolts are split in two categories: the batches released upstream CHG (blue) and the batches released upstream CHR.

As revealed by Figure 4, upstream CHG, a total of 147 smolts have been released, split into 3 batches spread during end of March to end of April 2021. Among these smolts, 112 have been detected upstream CHG. The two following sites, CHA and CHN were not equipped by a telemetry network consequently we don't know how many smolts passed through these sites. 29 smolts were detected upstream CHR, 5 get definitely lost in the Albert Canal and 18 were detected upstream CHM. 15 smolts were detected in CHL and finally 8 were detected downstream at the border with The Netherlands.

The total success of migration of the smolts through this stretch of the River Meuse was 5.4%. During the reference years in 2017, among 60 smolts released upstream CHG, 0% reached CHL, only one smolt succeeded to reach the upstream area of CHR.

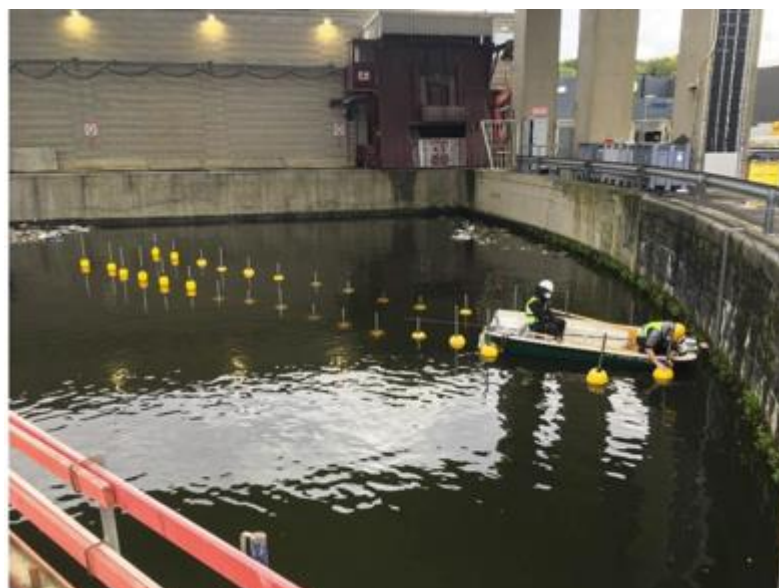
At CH Grands-Malades, two different pilot solutions have been deployed. First, an electrical barrier has been installed in the intake canal in an angled position aiming to guide salmon smolts towards the left corner of the water intake, where a bypass has been implemented. The electrodes are composed by stainless steel pipes, anchored to the bottom and kept in vertical position thanks to buoys (Figure 5). The dimensions and technical details are described in the C1 deliverable report (Leysens 2020).

Figure 5 : Drawing and picture of the electrical barrier in the forebay of CHG.

When starting the turbine after the installation, the lines of electrodes started to incline with the current and the closest electrodes entered in contact with the screens of the turbines. Consequently, a total of 10 electrodes had to be reduced in height, reducing the electrical field near the surface in the last 10 m of the barrier close to the corner of the bypass.

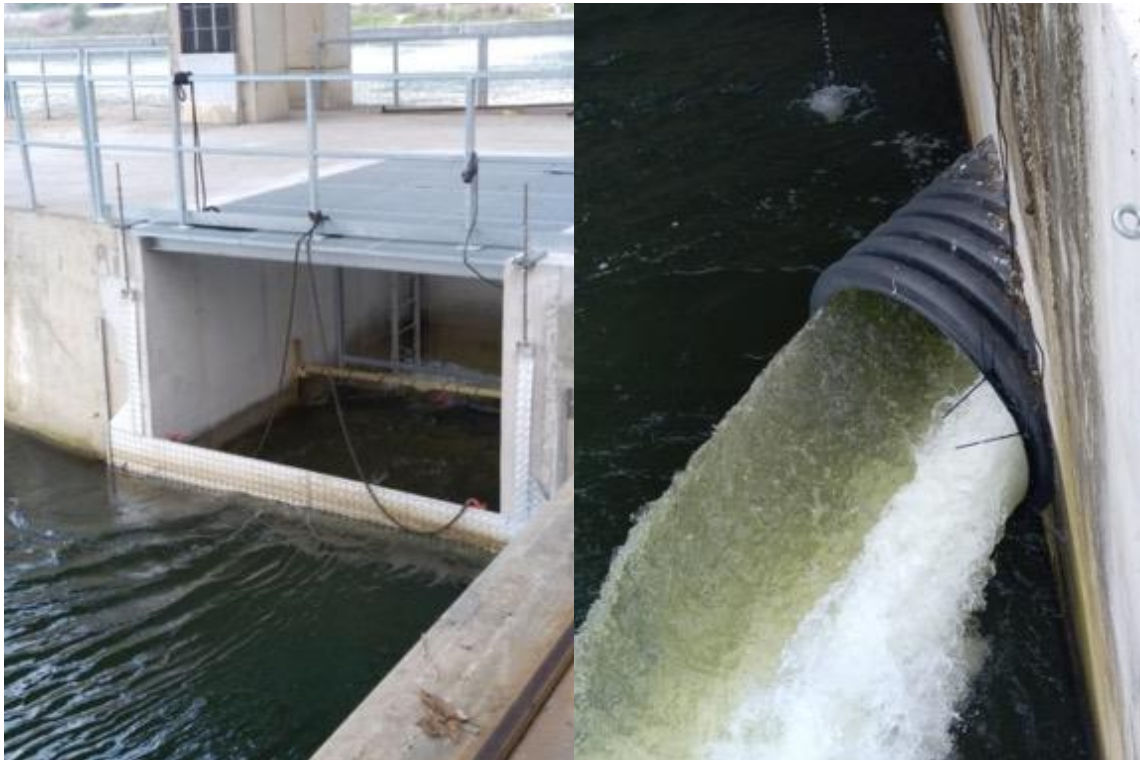
The bypass has been designed in the A3 action (Epicum et al. 2019) and after implemented with success as described in the CA deliverable report (Murillo Calvo & Leysens 2021). Figure 6 presents the pictures of the bypass. The inlet section is 3 m wide x 2 m deep and has a nominal discharge capacity of 3.4 m<sup>3</sup>/s.

Figure 6 : pictures of the entrance (left) and outlet (right) of the bypass designed in CH Grands-Malades.

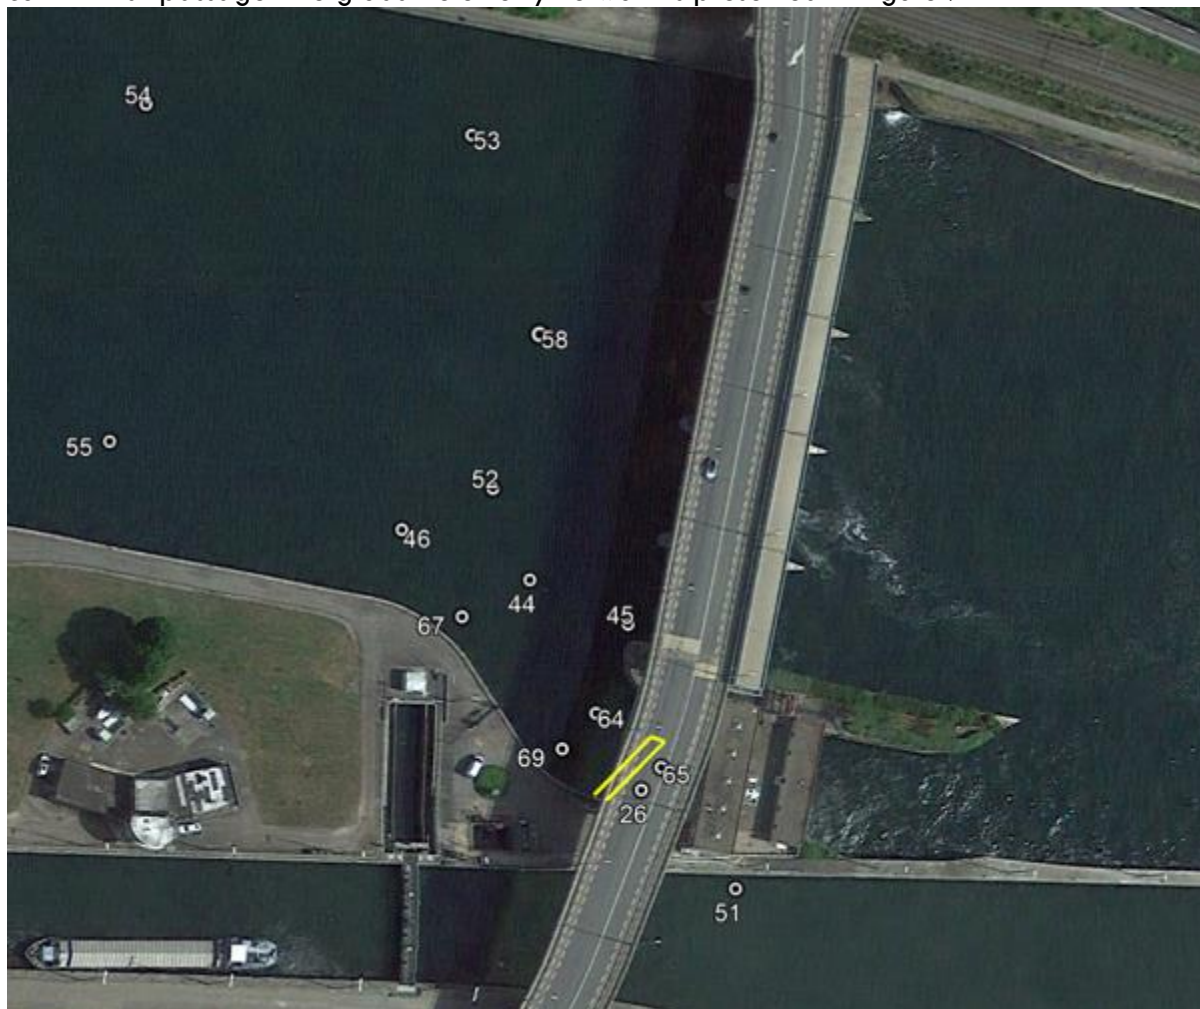
Figure 7 : 2D telemetry network installed at CHG (up) and CHR (down). Hydrophones 64, 65, 69 and 26 are covering the forebay.

To evaluate the efficiency of the pilot solutions at CH Grands-Malades, a total of 13 LOTEK WHS 4250 hydrophones have been deployed upstream the dam and the powerhouse, 1 hydrophone was covering the sluice and 2 hydrophones were installed 1500 m downstream to confirm fish passage. The global telemetry network is presented in Figure 7.

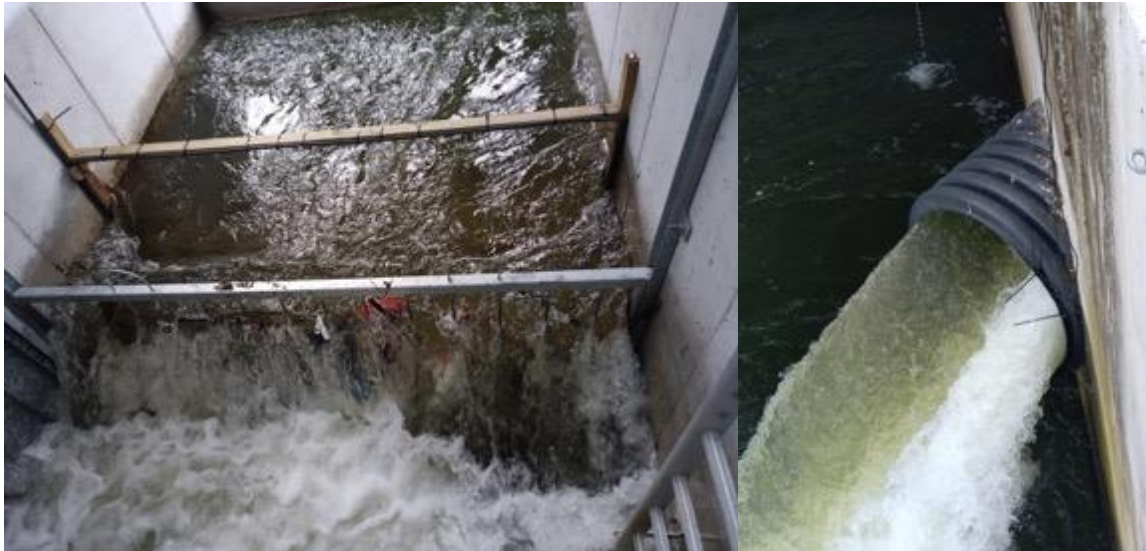
Figure 9 : view of the wooden frame in the upstream part of the bypass (left) and the cable around the outlet tube downstream (right).

This conducted us to test in emergency RFID antennas at the upstream and downstream end. 2 loops of cable around a wooden frame installed by divers in the bypass inlet have been installed upstream, and around the bypass outlet downstream (Figure 9).

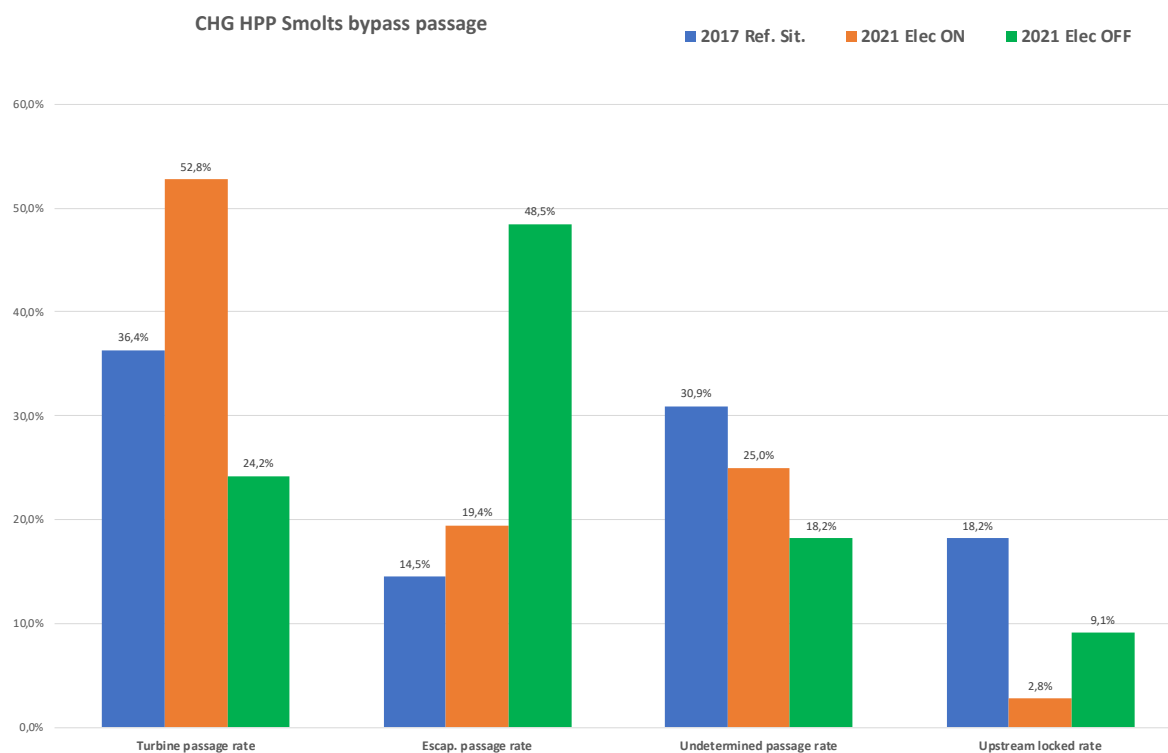
Figure 10 : smolt passage repartition (%) in 2017 (reference year in blue) and 2021 with electrical barrier ON (orange) and electrical barrier OFF (green). Escapement passage considers only dam and/or bypass passage. Sluice passages are not considered in this analysis.

Turbine passage in 2021 with the electrical barrier ON was higher than in 2017, but lower when the electrical barrier was turned OFF (Figure 10). These observations are strangely linked with the increase of escapement passage observed during both batches in 2021 compared with 2017 but can be better explained by the undetermined passage rate that decreases with an opposite trend than the escapement rate.

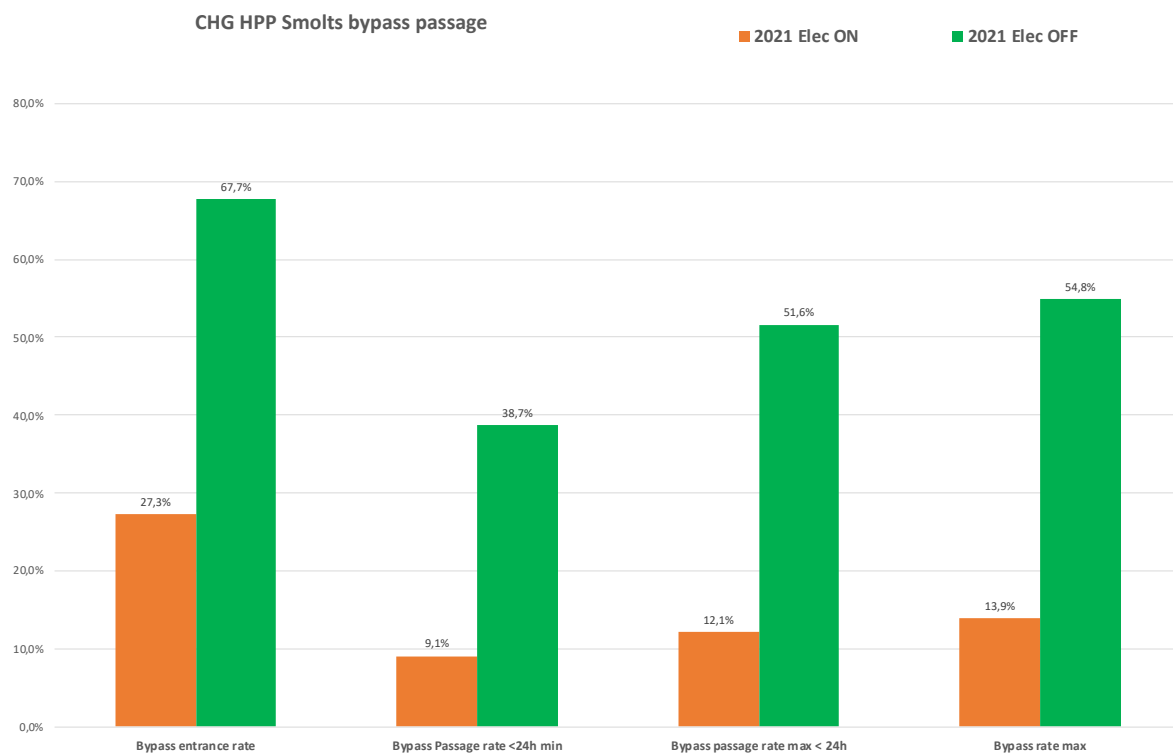
Figure 11 : Bypass entrance rate and passage rate observed in CHG in 2021. Bypass passage rate max is obtained including all smolt only detected by the upstream RFID antenna as last detection on the site, but not confirmed by a detection by the downstream RFID antenna.

The variables used to calculate the bypass efficiency were much higher when the electrical barrier was OFF than with the electrical barrier ON (Figure 11), suggesting a negative effect of the electrical barrier on the bypass efficiency.

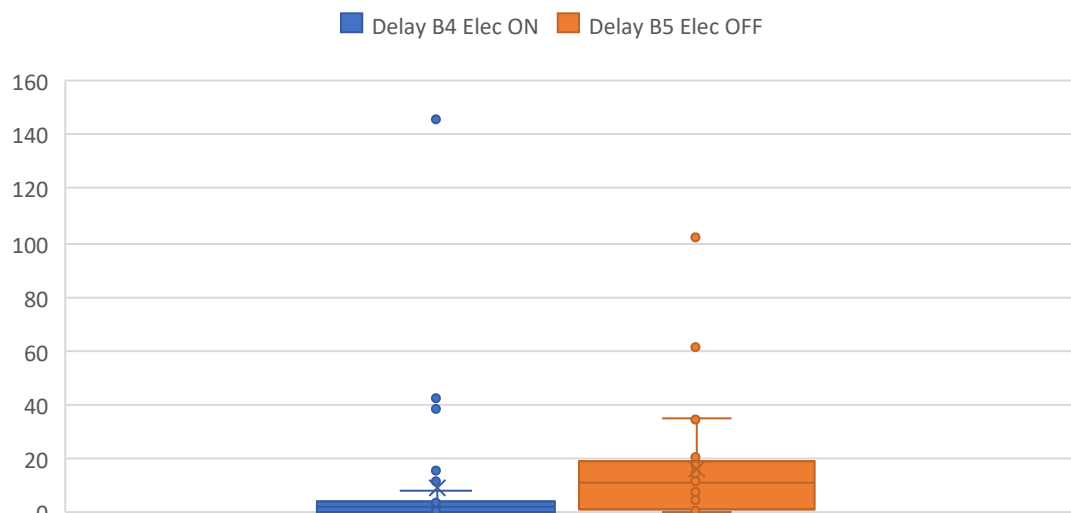
Figure 12 : box-plot of the delay (Y, hour) between fish first and last detection upstream the site for the batch 4 with the electrical barrier ON (N = 36, blue) and the batch 5 with electrical barrier OFF (N = 33, orange).

The delay of passage for batch 4 with the electrical barrier ON was significantly lower (Wilcoxon Test,  $P = 0.0012$ , median value Batch 4 = 1.76 h; median value for Batch 5 = 11.08h). This comparison suggests that the electrical barrier in operation induced a faster transit towards downstream than when turned off.

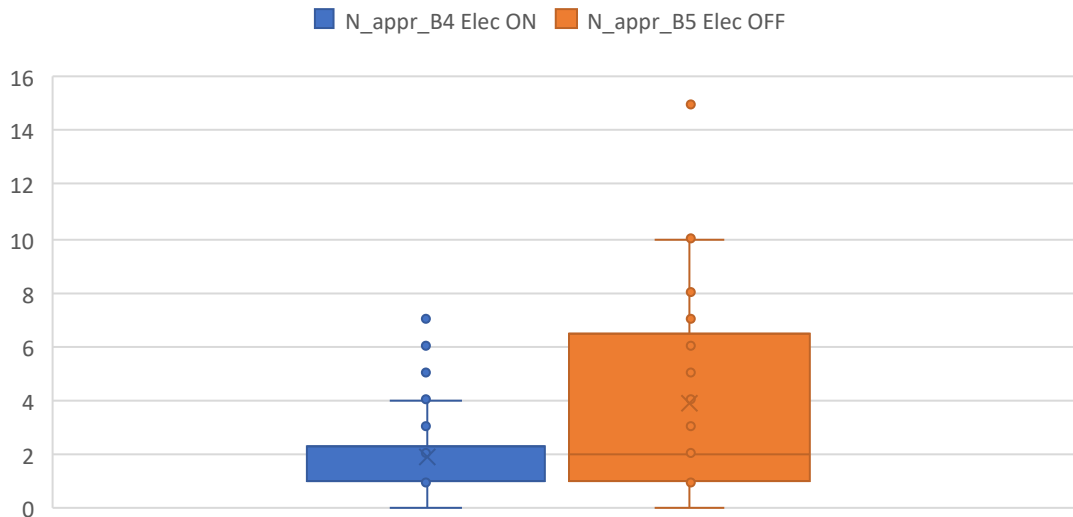
Figure 13 : Blox-Plot of the number of approaches in the forebay (Y, number) for smolts from batch 4 with electrical barrier ON (blue) and batch 5 with electrical barrier OFF (orange), after exclusion of 2 extreme values.

significant difference between the number of approaches (Wilcoxon test,  $P = 0.0159$ ), confirming that the smolts exposed to the electrical barrier with power ON exhibited less hesitation in the forebay than the smolts of the next batch with the electrical barrier OFF (Figure 13).

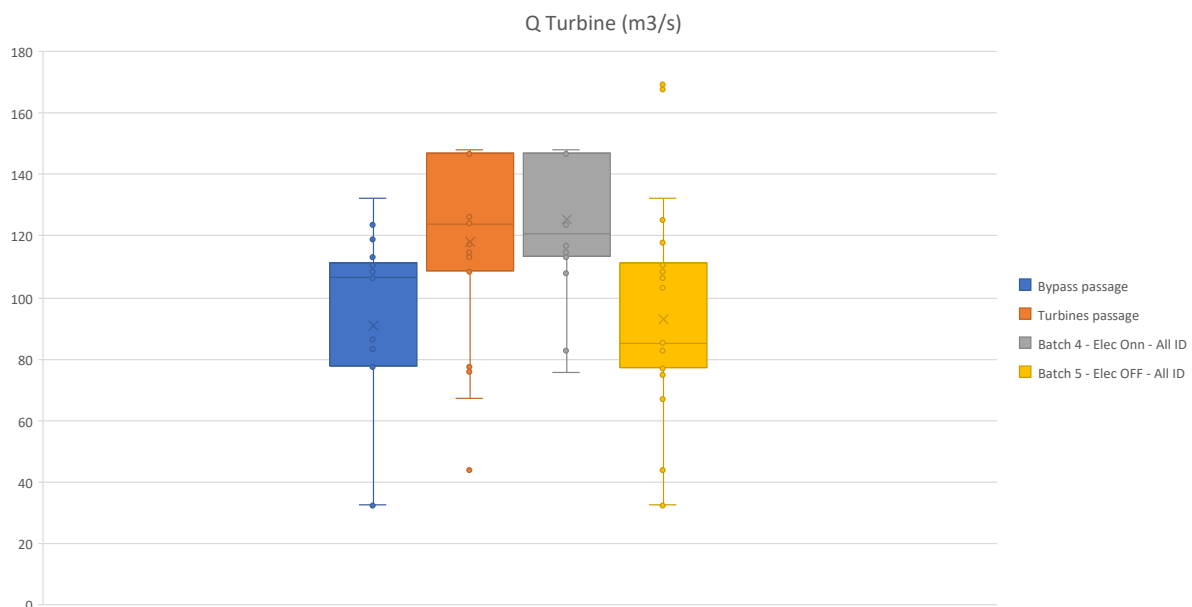
Figure 14 : blox plot of the turbine discharge (Y,  $\text{m}^3/\text{s}$ ) for the smolts using the bypass ( $N = 21$ , blue) or the turbines ( $N = 31$ , orange) for both batches pooled together; and for all passages of smolts from batch 4 ( $N = 36$ , grey) and batch 5 ( $N = 33$ , yellow).

A lower discharge for Batch 5 means that some turbine group was more often stopped than for Batch 4. In particular, Group 4, close to the bypass entrance, is likely the most influential for bypass attractivity since its nominal operation induces a vortex in front of the entrance of the bypass. Moreover, this Group has very poor regulation capacity, meaning that it can be considered as an OFF/ON Group, the regulation being applied mostly on Group 3 on this site. As revealed on Figure 15, group 4 was most of the time turned OFF during the period of passage of smolts belonging to Batch 5.

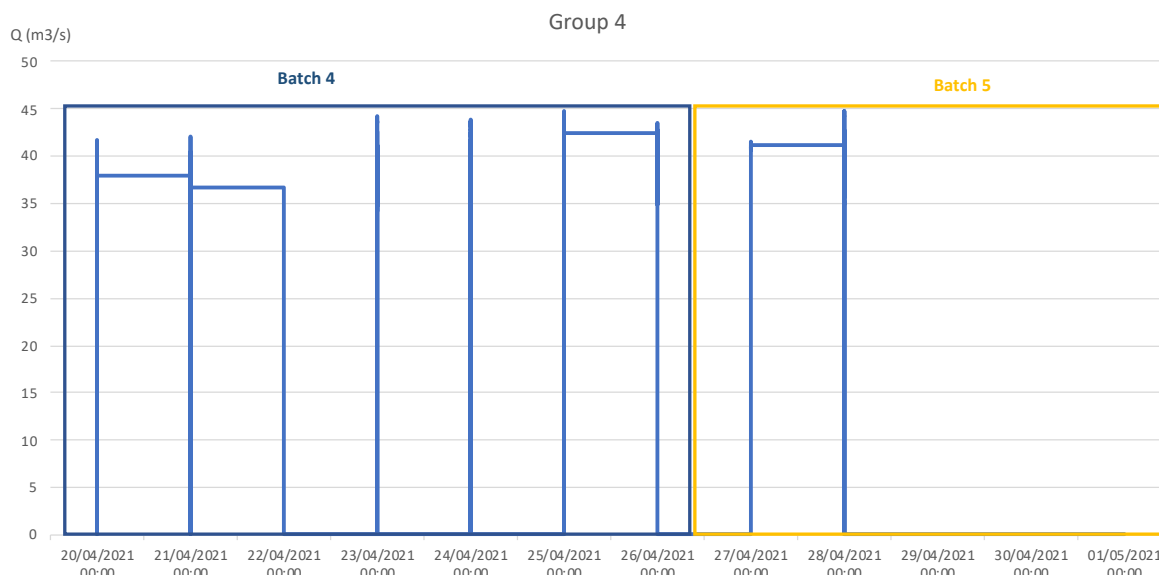
Figure 15 : Evolution of the Group 4 discharge at CHG for batch 4 and batch 5 during the period of smolt passage.

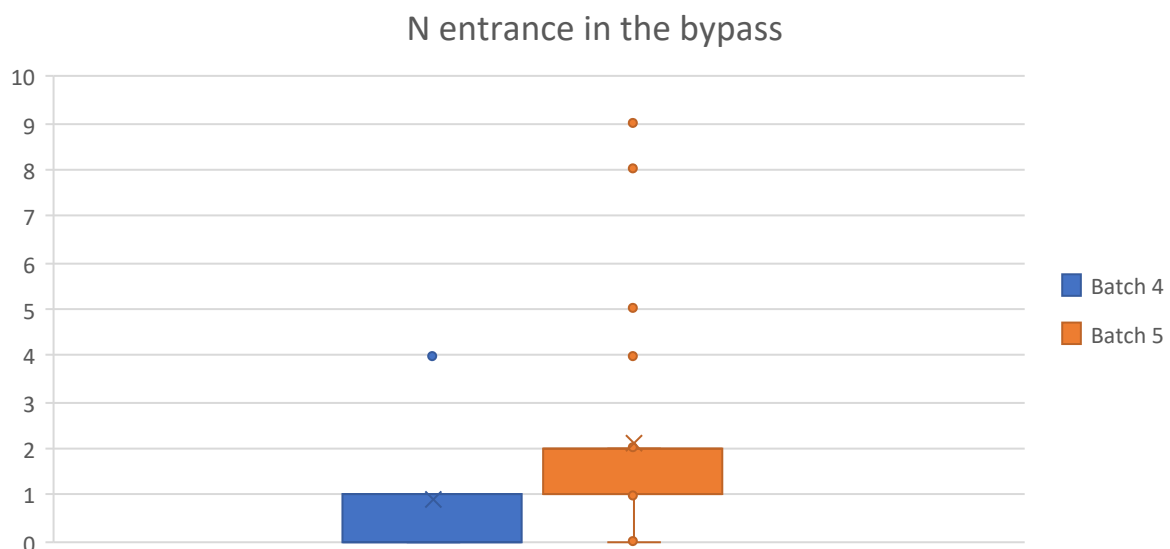
Figure 18 : Blox-Plot of the number of detections per ID by the entrance RFID antenna of the bypass for batch 4 (electrical barrier ON) and batch 5 (electrical barrier OFF).

To evaluate the performances of the bypass, we compared the number of detections for each ID at the entrance of the bypass by the RFID system (Figure 18). The number of entrances in the bypass was obviously higher for batch 5 than to batch 4 while the difference was not significant (Wilcoxon test, P = 0.064).

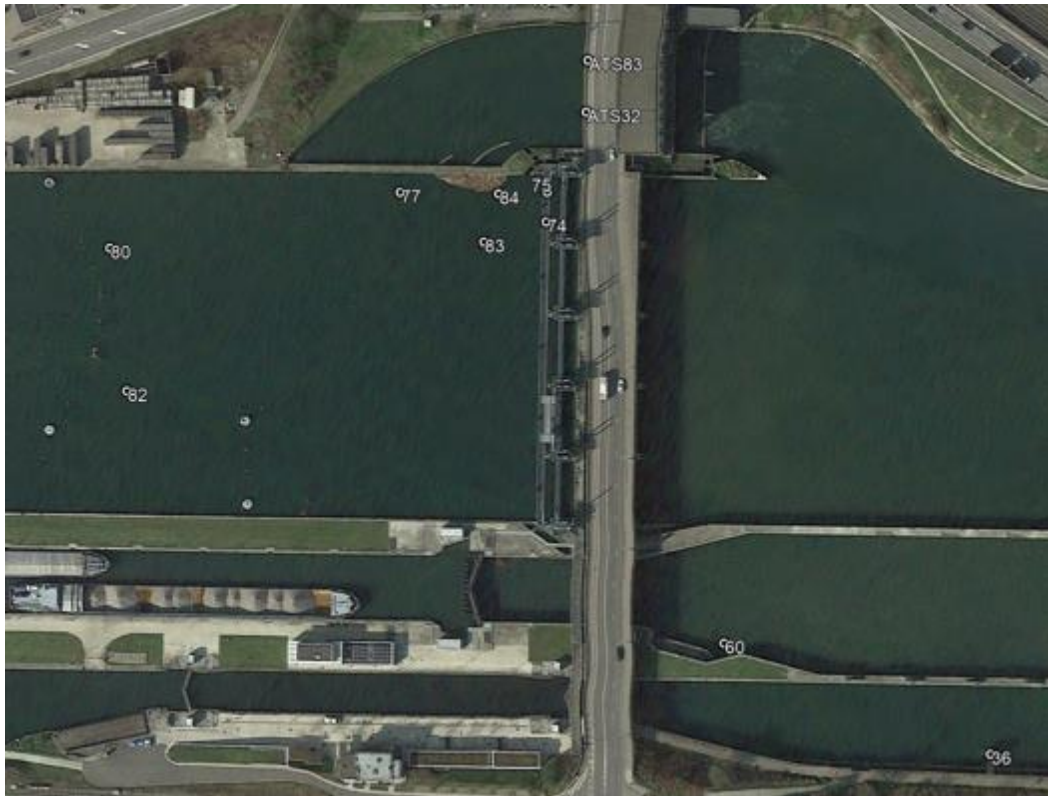
Figure 20 : view of the telemetric network installed at CH Ramet during the smolt 2021 survey.

At CH Ramet, the telemetry network was composed by 9 LOTEK WHS 4250 receivers located in the main river to distinguish several key areas (Figure 20) : arrival on site (80-82), detection along the intake and the dedicated spillway (74, 75, 77, 83, 84), sluice passage (36, 60). 2 ATS SR3017 receivers (32, 83) have been installed near the turbine screen to detect smolt passage through the HPP. Additionally, 2 LOTEK WHS 4250 have been installed 1.500 m further downstream to confirm passage.

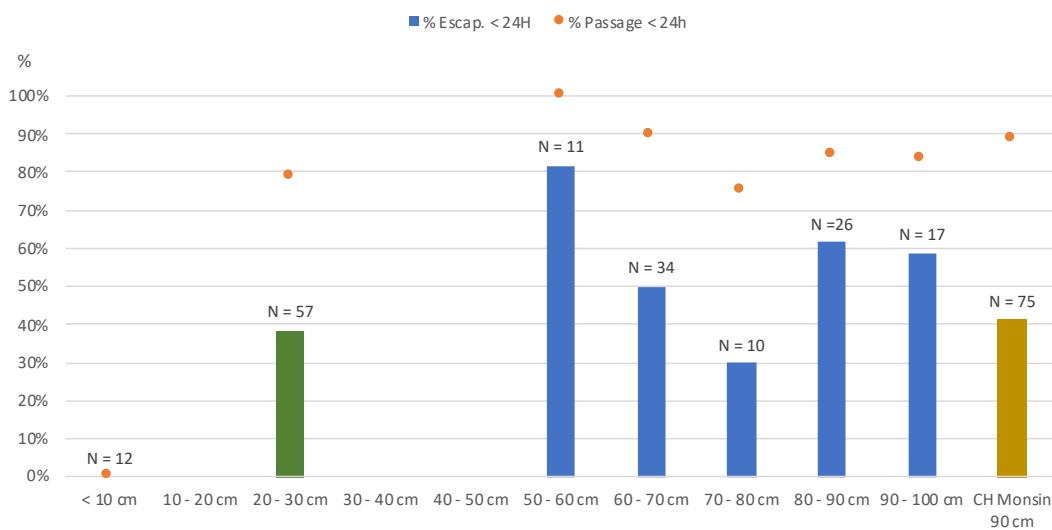
Figure 22 : Escapement rate by the open spillway (%) in less than 24h in relation with the water level measured by the SPW on the spillway adjacent to the powerhouse in Ramet and Lixhe and opposite to the powerhouse in Monsin. Only value with more than 10 smolts are used for the analysis. Green column is supplied by value obtained only in Lixhe, blue columns are related with Ramet data and orange column is for Monsin. The N presents the total number of observations used to calculate the escapement rate. Orange spot are showing the proportion of the smolts that passed the spillway within 24h of delay in relation with all spillway passage of smolts.

The figure shows a robust escapement rate of 39% for a water level of 20-30 cm within 24h after the arrival on site. This result being obtained 100% by data from CHL. The dam escapement rate varied between 30% and 82% for water level between 50 cm and 100 cm.
