DOWNSTREAM FISH MIGRATION ALONG THE LOW MEUSE RIVER

Installation of a pilot behavioral barrier and downstream fish pass at pilot site 1

Deliverable – On site installation report

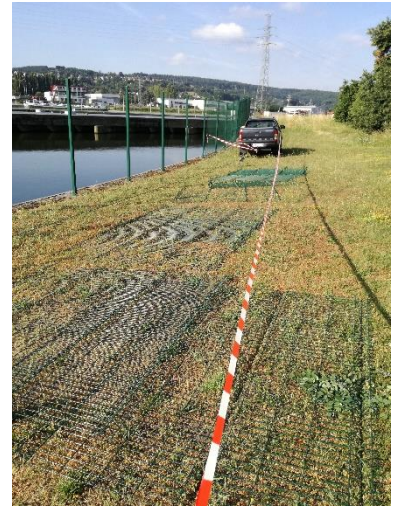
Figure 3 : Work areas

The main risks are related to the fall of a person into the water. Several solutions were implemented to make the workers as safe as possible. First at all, we placed a lifeline on the plunging wall to secure the area. Along the bank we used a temporary lifeline connected to two vehicles. All work areas are marked out. Wearing the lifejacket is mandatory close to the water if the lifeline is not used.

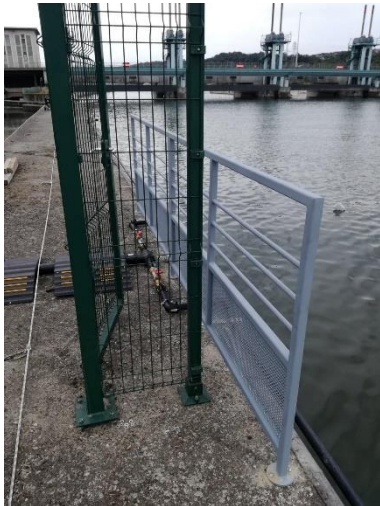
Figure 4 : Railings

We have provided railings for the maintenance of valves and the exhaust valve. The use of a duckboard facilitates the maintenance of the exhaust valve.

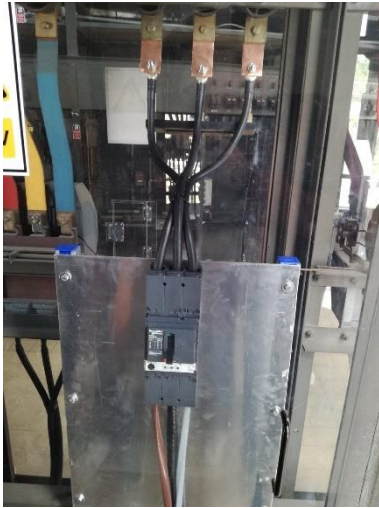
Figure 7 : Circuit breaker

The power supply works are insured by New elec. They set up a circuit breaker and a cable with 100m length (3*220V). They do the connection between the compressor and the cable 4*220V. They use existing cable trays and they put a new one next to the compressor. The power supply area is secured by a steel protection.

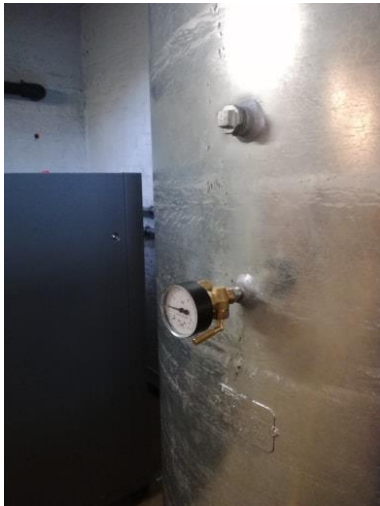
Figure 13 : Manometer

Unfortunately, there has been a delay in delivery in particular for the compressor delivery. The compressor was delivered on August 30th. The HPP's bridge crane was nonfunctional so we ordered a truck crane to move the compressor and the steel tank. Equipment were unloaded to the ground with the truck crane and were put in place with a pallet truck. The elements (compressor, steel tank and filters) are positioned to facilitate maintenance. All the elements of the compressor are reachable. The assembly is supported by Mecafluid. PEHD and hose pipe are used to perform connections. An automatic purge is placed under the tank because the steel tank will be filled with water daily. The purge is powered by the 24V output from the compressor. The evacuation of dirty water is rejected on the stairs to the Meuse. A safety valve and a manometer are set up on the steel tank for maintaining the security.

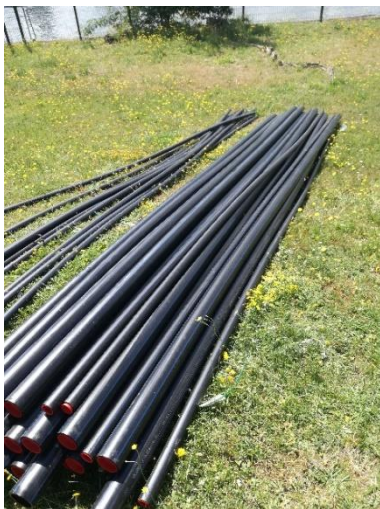
*Figure 16 : HEPD pipe 90mm
50mm*

Meca fluid is in charge of the supply and the installation of piping. We use HDPE pipe with electro-welded connections. We chose this type of material because it is easy and quick to set up.

If the effectiveness of the bubble barrier is proven we will invest on a way to protect the pipe especially against UV. The HDPE pipe has been raised for the passage of UV protection. Aluminum clamping rings used are not tight to allow the pipe to move in the hose clamps.

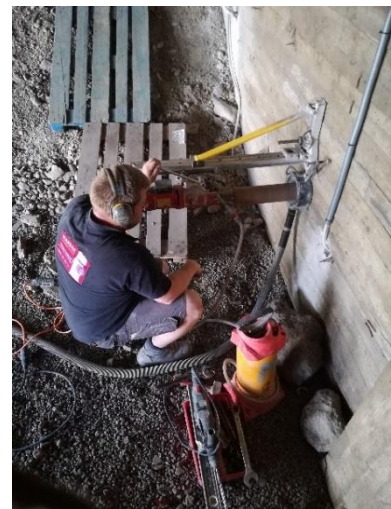
*Figure 18 : Drilling
equipment*

The compressor being inside the hydropower plant, two drilling cores were made for the passage of the pipe. The main difficulty of the drilling is the presence of electric cable behind the concrete wall. Mecafluid used a company specialized in coring in order to avoid an accident.

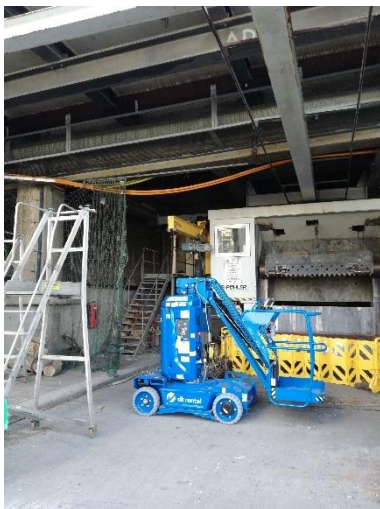
Figure 19 : Basket

One part of the pipe is fixed on the bridge, we used a basked to secure the personnel.

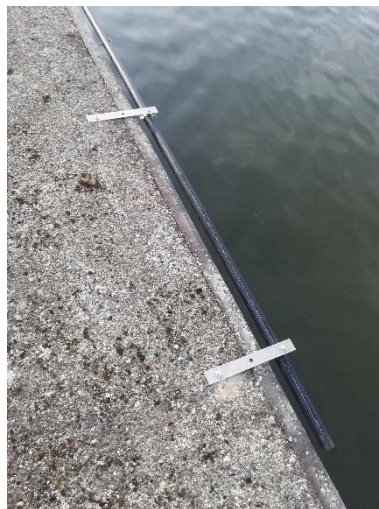
Figure 20 : Metal legs

Metal legs have been fixed along the plunging wall to support the pipe feeding the downstream of the bubble curtain. Compensators are installed along the HDPE pipe to limit expansion. Block valves are located at the upstream and the downstream ends of the plunging wall.

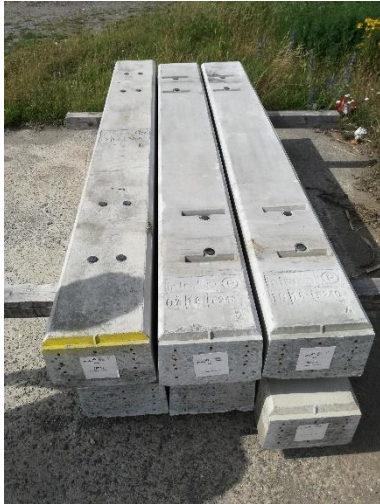
Figure 22 : Railway sleepers

We used railway sleepers as anchors. Prefer company provided us these concrete blocks. We made the mounting part to connect the bubble barrier to the concrete blocks.

Hydroscah was in charge of the assembly. They drilled the railway sleepers and they fixed the mounting parts. In total, 6 railway sleepers were used. The removal of concrete blocks is provided by a truck crane.

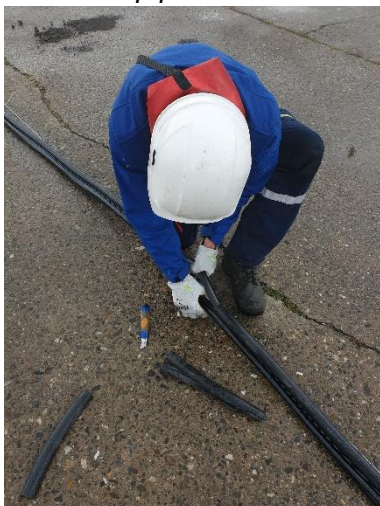
Figure 32 : Extract the steel cable

We uncoiled the bubble pipe on the quay. We extracted the steel cable at the landmarks' cord used by the divers before. To prevent slipping of the steel cable into the rubber, we made a loop with the steel cable and a cable clamp. Then the bubble barrier is carefully and slowly lowered into the water to avoid a tear. All connections are made under water by the divers. During the test pressure, we have detected a leak on the bubble curtain, divers plugged it with a steel pipe.
